This is the Performance Audit Group's (PAG) annual report on the management and maintenance of Scotland's trunk road network for 2020/21.

PAG's role is to audit, monitor and report on the performance of the Operating Companies (OCs), and this report summarises the extensive work carried out by the PAG multi-disciplinary team throughout the year.

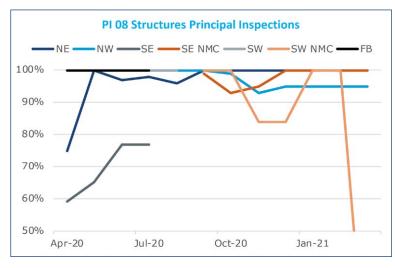
Figure 23

Operating Companies are required to undertake inspection of all bridges and other structures on the trunk road network at regular intervals. There are several structures outwith the trunk road boundary which are also inspected. General Inspections (GI) are to be undertaken every 2 years with a Principal inspection (PI) every 6 years. The contractual Performance Indicator for Principal Inspection (Figure 23) and General Inspections (Figure 24) is a measure of achievement of inspections against programme. Figure 25 shows the average PI over the annual period.

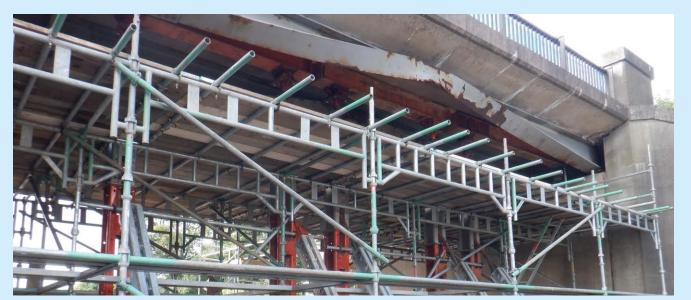
This two-span overbridge connecting the villages of St Madoes and Glencarse, just east of Perth, was struck by the arm of a tracked excavator being transported on a low loader on 31st October 2019. The impact caused severe damage and deformation to two of the five steel beams forming the composite steel-concrete bridge deck as well as damage to the bearings, deck concrete and a ducted water main in the verge.

Temporary works and propping for beam replacement

View of repaired beams from A90 carriageway level

Following a period of options appraisal, competitive tendering and design, the main site works commenced in August 2020. Taziker was appointed as the main subcontractor for the repair. The works involved the insitu cutting out and replacement of the web and bottom flange of the two damaged primary members over the eastbound A90, as well as bearing replacement, steel blasting and repainting, concrete repairs and groundworks.

To maximise the occupation of the trunk road network and local authority road space, BEAR also undertook a refurbishment of the top side of the deck including concrete repairs, waterproofing, new asphaltic plug joints and resurfacing.

The main repair was completed in late September 2020 with topside deck refurbishment works concluding around the start of December.

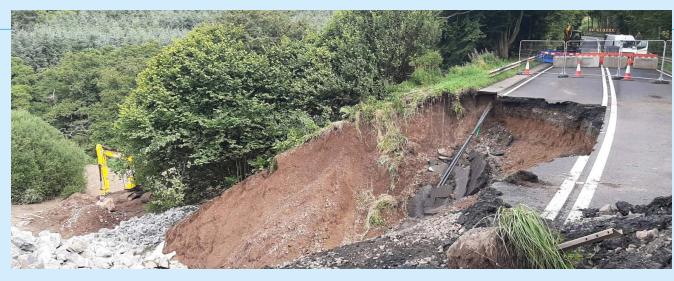
Overnight on Tuesday 11 August 2020 severe weather with high intensity rainfall resulted in watercourses and drainage systems on the A68 being inundated. This resulted in the water overtopping and infiltrating the existing embankment at A68 Fala Tunnel. The flow of water led to the embankment failing and washing out, leaving a deep crater resulting in the closure of the A68 trunk road.

One of the key elements of the repair was to understand what caused the failure of the embankment and develop a solution in a timeous fashion. BEAR's Geotechnical experts attended site to carry out the initial investigation and inspection works.

An emergency process developed following previous emergencies of a similar nature was introduced.

This allowed both our geotechnical design engineer and the independent checker to work together on site to ensure the repair works were completed as quickly as possible whilst ensuring a compliant design.

Additional drainage was installed to provide further resilience to the area. This also included the provision of an upgraded Vehicle Restraint System through the bend location. BEAR worked closely with the local supply chain to ensure the availability of materials throughout the works including extended opening hours of the supply quarry. The carriageway opened to traffic in less than four weeks from the initial extensive failure.
